VULNERABILITY OF DIKES OR GRAVITY DAMS

Better estimate the strength of rockfills

Christophe DANO, 3SR Laboratory

RISK
Summer
School
2024

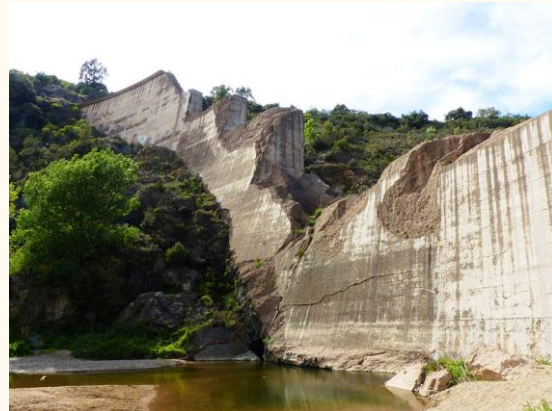
Malpasset (France), 1959,

Quality of the abutment

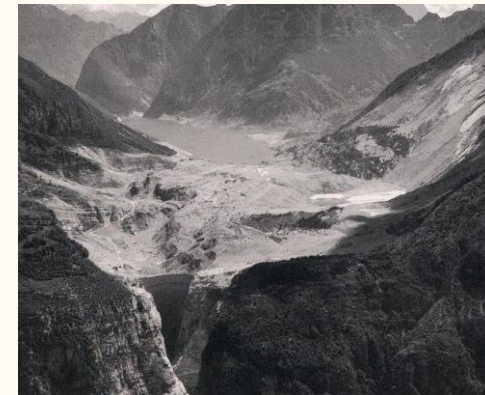
Vajont (Italy) 1963,

Landslide in the reservoir

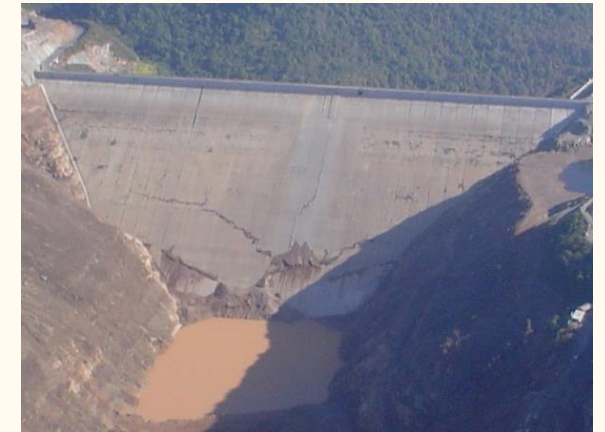
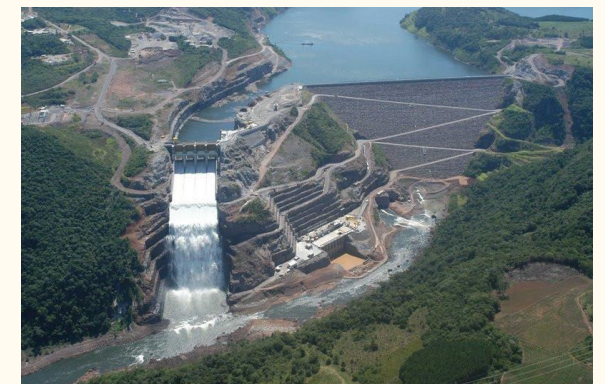
CASE STUDY 1 / CAMPOS NOVOS DAM (BRAZIL – 2005)

Hydro-power, H 202m

FAILURE of the concrete face during 1st filling

CAMPOS NOVOS CFRD

- 1st filling of the reservoir

Contact between water and rock blocks

Breakage of blocks at the base

Settlement of the rockfill +
bending of the concrete face (traction)

Failure of the concrete face + leakage

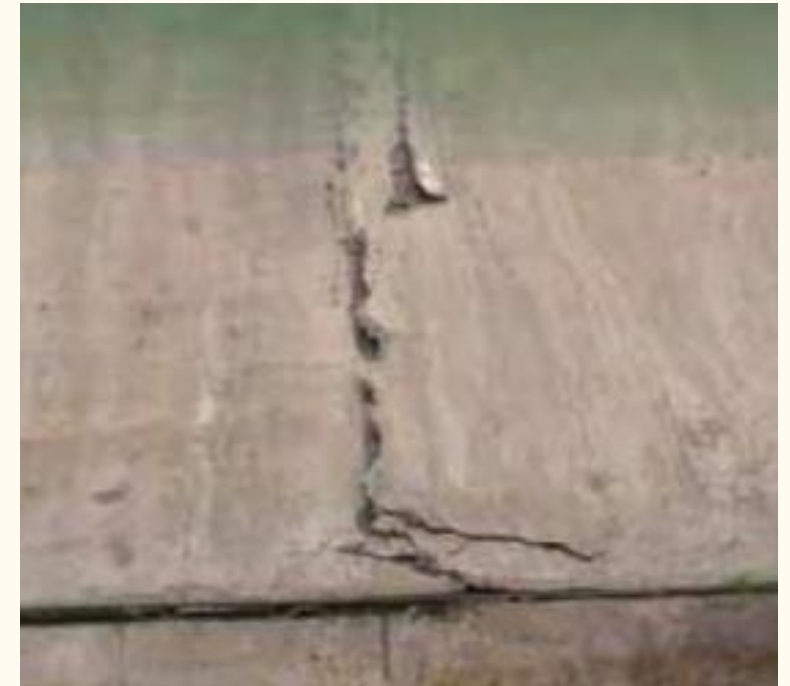
CASE STUDY 2 / MOHALE DAM (LESOTHO – 2006)

H 145m,

FAILURE of the concrete face during 1st filling

+ HEAVY RAINS

Leakage of 600 l/s

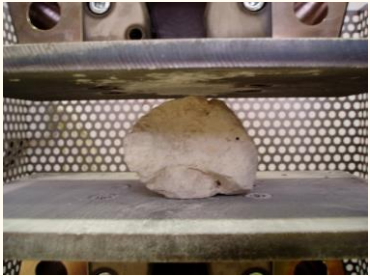
Protodyakonov tests
Franklin tests

$$\sigma_f \propto \frac{F_f}{d^2}$$

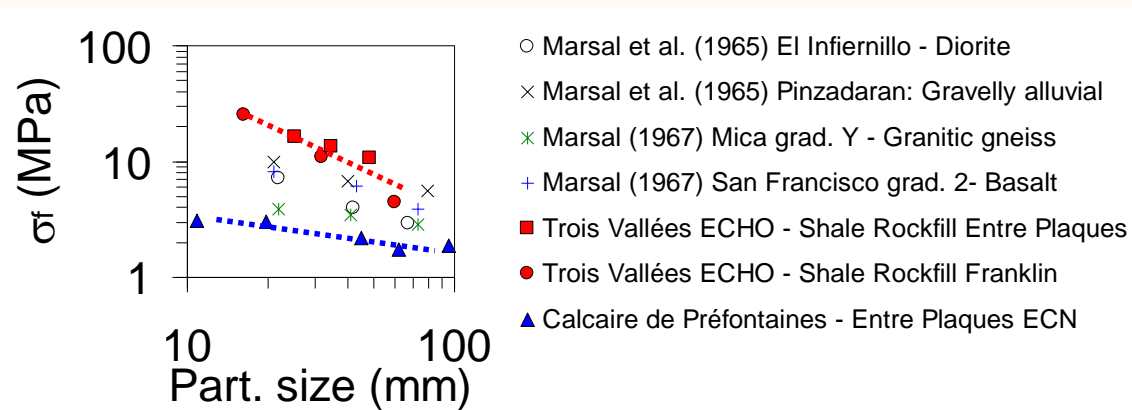
CONCLUSION: 1

YES THERE IS A SCALE EFFECT AT THE GRAIN SCALE

(Weibull 's distribution)

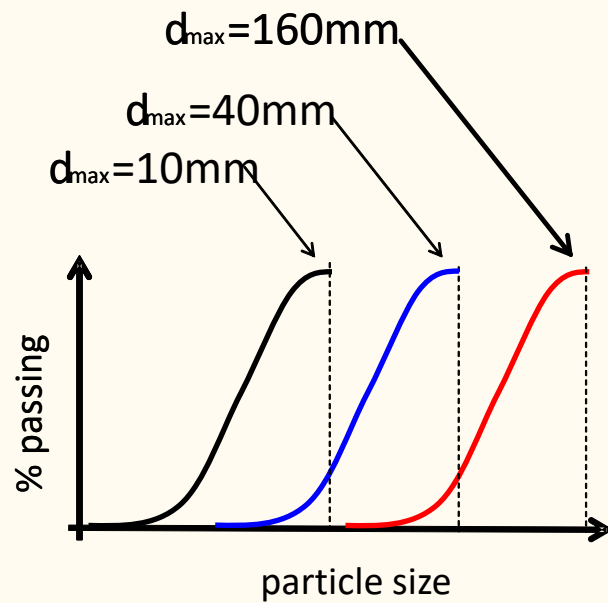
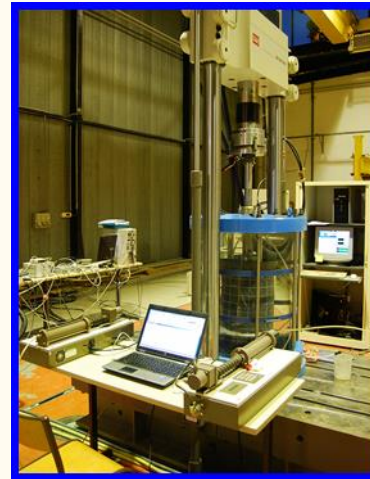
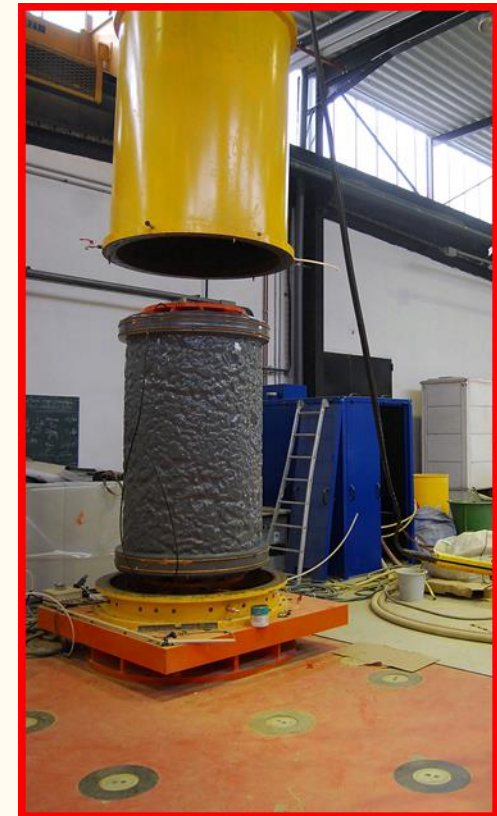
SAMPLE SIZE : at least 6 to 10 times the maximum grain size

Extrapolation to rockfill in the field

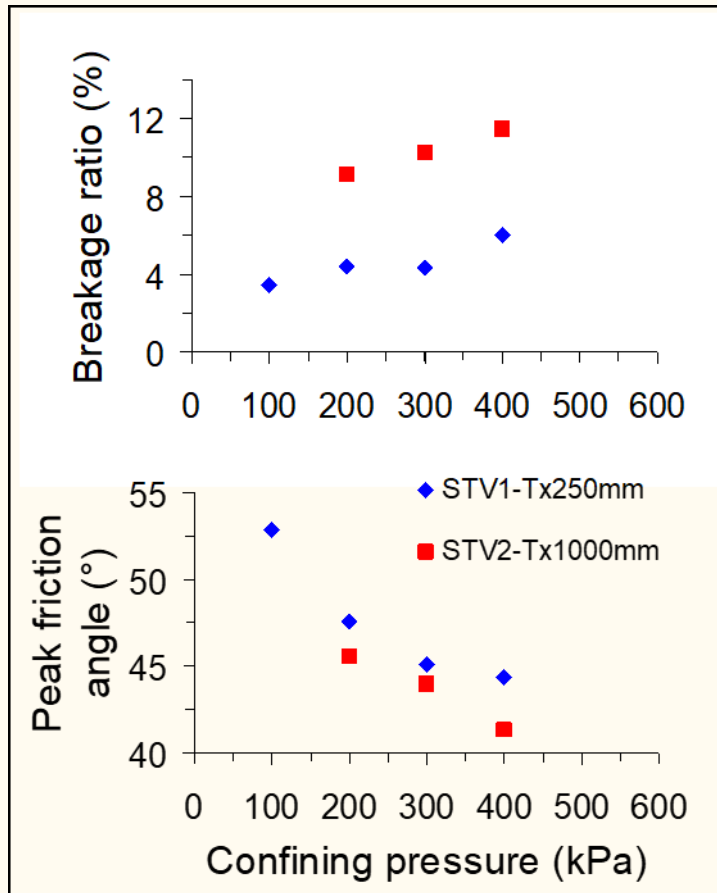
CONCLUSION: 3

YES

- Decrease of the shear strength with increasing particle size
 - Increase of grain breakage
- More compressible volumetric behaviour (more prone to settlement)

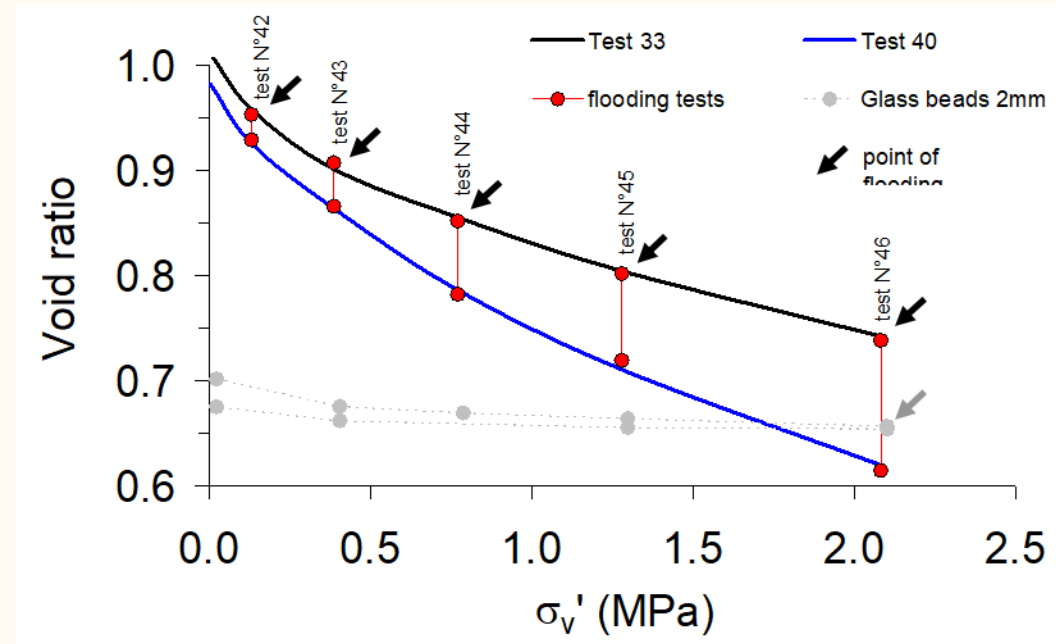
1D compression tests

Clear instantaneous effect of imbibition

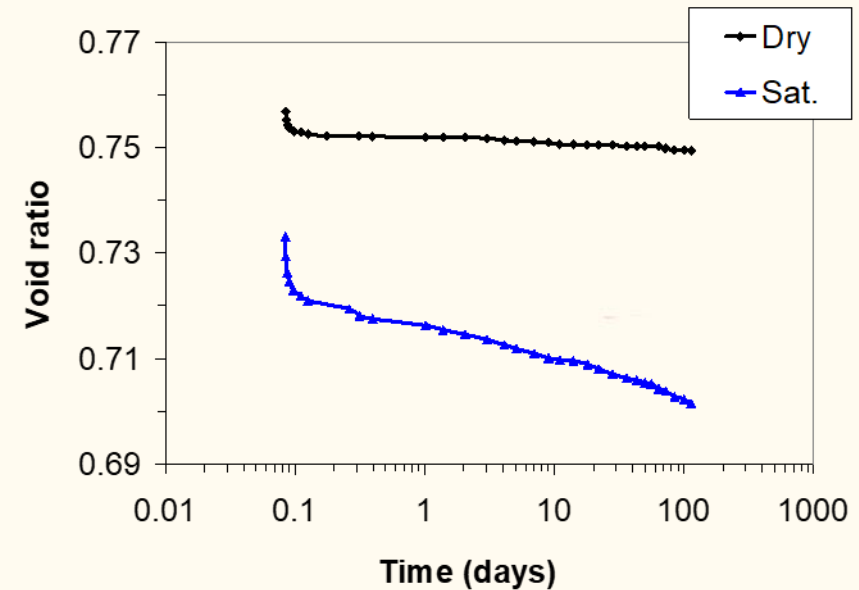
1D compression tests

Long-term effect in both dry or saturated rockfills

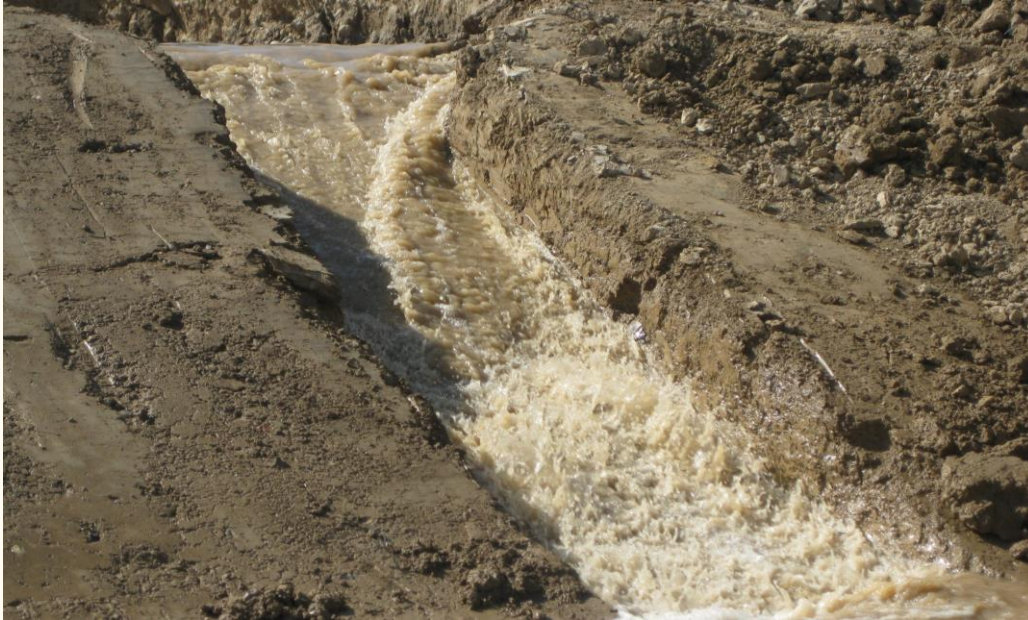
External erosion (backward)

Detachment of particles downstream

Loss of stability

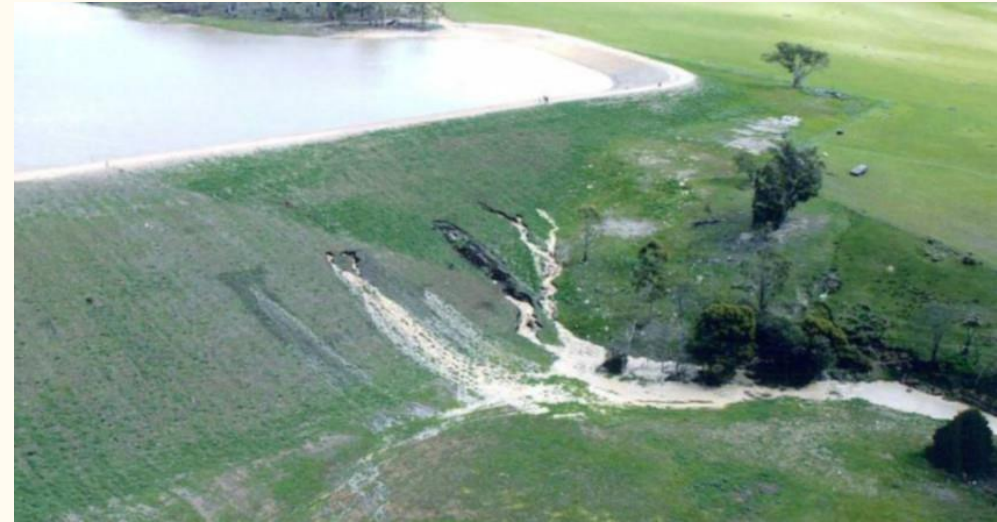
Internal erosion

Flow of small particles inside the structure

Change of mechanical and hydraulic properties
that could lead to failure
